Manhole Inspection Summary

Manhole # S49K__017MH

Insp Date: **2/10/09 2:19 PM**

Location Address: **700 FOSTER-FAIT-ALLEY**

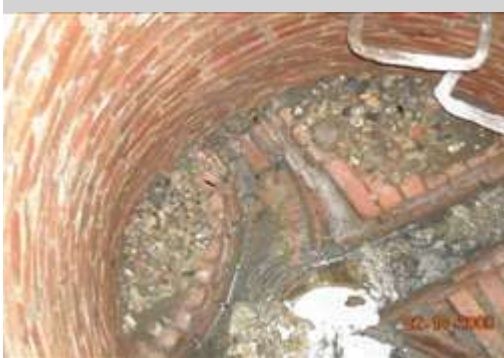
Defect 4

Bench ☒ Exists Material: **Brick** ☐ Parged
Condition: ☐ Sound ☐ Cracked ☐ Root Intrusion ☐ Deteriorated ☐ Leaks ☒ **Debris**

DEBRIS ON BENCH

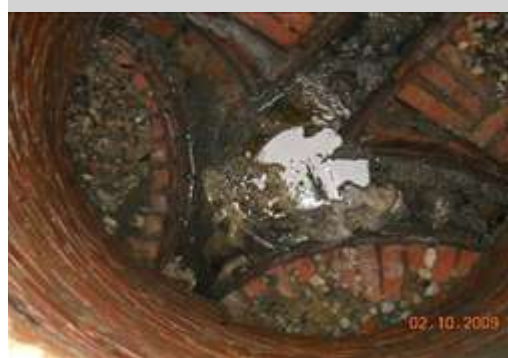
Defect 3

Channel Material: **Brick** ☐ Parged
Channel Exposure: **Fully Open** Junc Dist: **0** nearest .5 ft. Azimuth: **0**
Condition: ☐ Sound ☐ Cracked ☐ Root Intrusion ☐ Deteriorated ☐ Leaks ☒ **Debris**

DEBRIS IN CHANNEL

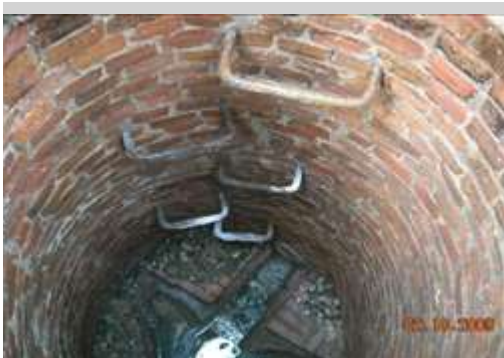
Defect 2

Steps Count: **5** Missing: **0** ☒ **Corroded**

CORRODED STEPS

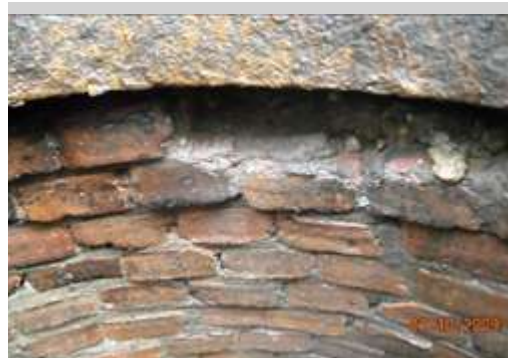
Defect 1

Chimney / Frame Adjustment ☒ Exists Material: **Brick** ☐ Parged Height: **3** (in.)
Condition: ☐ Sound ☐ Cracked ☐ Root Intrusion ☐ Loose Brick ☒ **Deteriorated**
Infiltration: ☒ None ☐ Joint ☐ Cracks ☐ Mortar ☐ Roots ☐ Wall

DETERIORATED CHIMNEY

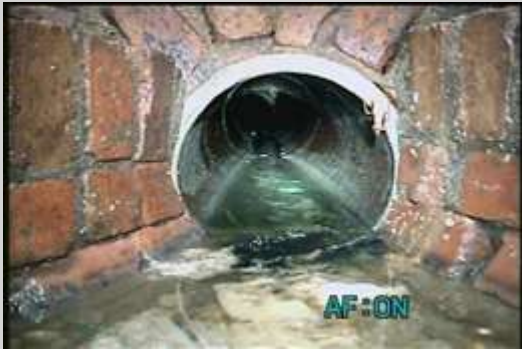
12 O'Clock Outflow

8 in. Circular Gravity Sewer
Pipe Out @ 12 Oclock

Pipe Height: **8.4** (in.) Rod and Bar (Angled)
Pipe Material: **Clay** ☐ Pipe Lined
Invert Depth: **8.91** (ft.) Flow Characteristics: **Slow**
Deposits: ☐ None ☐ Mud ☒ **Sludge** ☐ Debris ☐ Grease
Silt Depth: **2** (in.) Deposits Extent: **Light**
Infiltration: **None** Pipe Seal Cond: **Sound**
